NIST NCSTAR 1-2B

**Federal Building and Fire Safety Investigation of the
World Trade Center Disaster**

**Analysis of Aircraft Impacts into the
World Trade Center Towers
Chapters 1, 2, 3, 4, 5, 6, 7 & 8**

September 2005

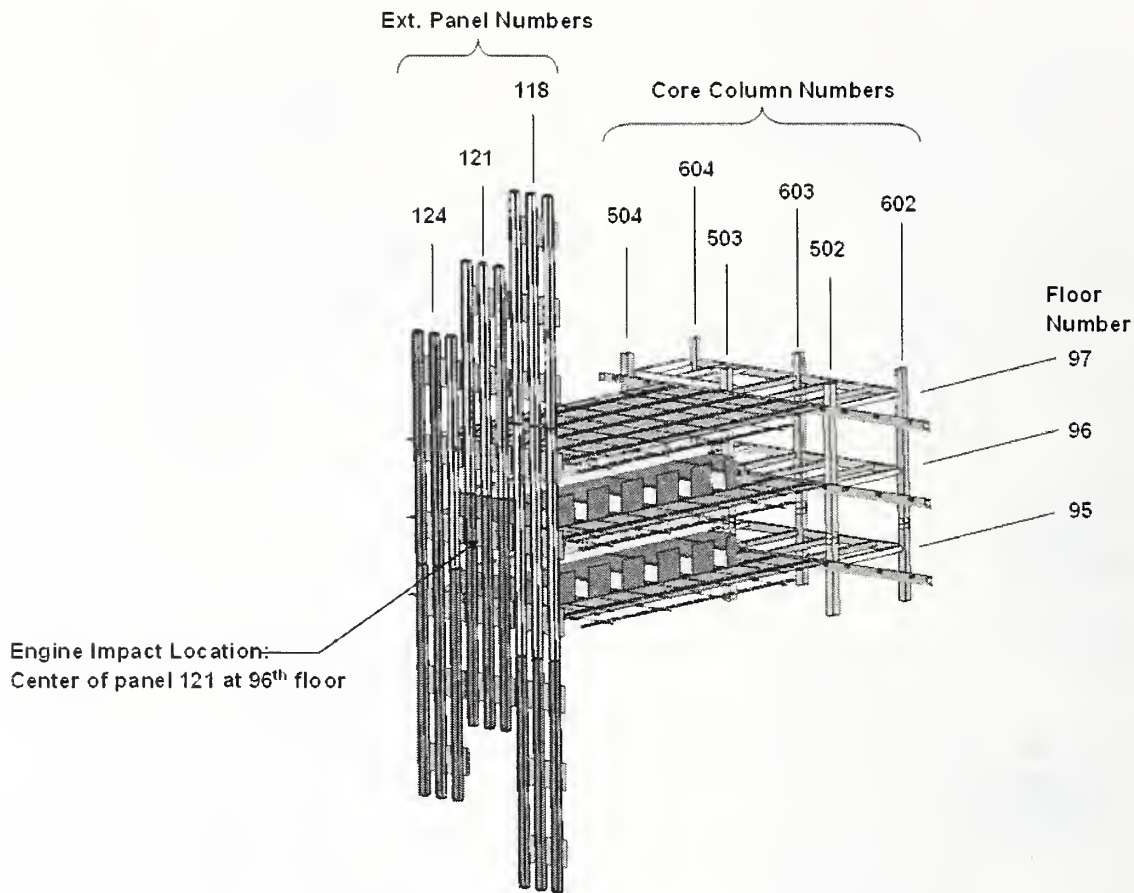
The subassembly analyses were used as a transition between the component level analyses and the global impact analyses. With the subassembly analyses, more complex structural behavior not captured in the component analyses could be investigated with significantly shorter run times than required for the global analyses. The subassembly analyses were primarily used to investigate different modeling techniques and associated model size, run times, numerical stability, and impact response. The final subassembly model used structural components from the impact zone on the north face of WTC 1. The structural components in the final subassembly model included the exterior panels, core framing, truss floor structures, and interior contents (workstations), Figure E-18.

Figure E-18. Final WTC tower subassembly model.

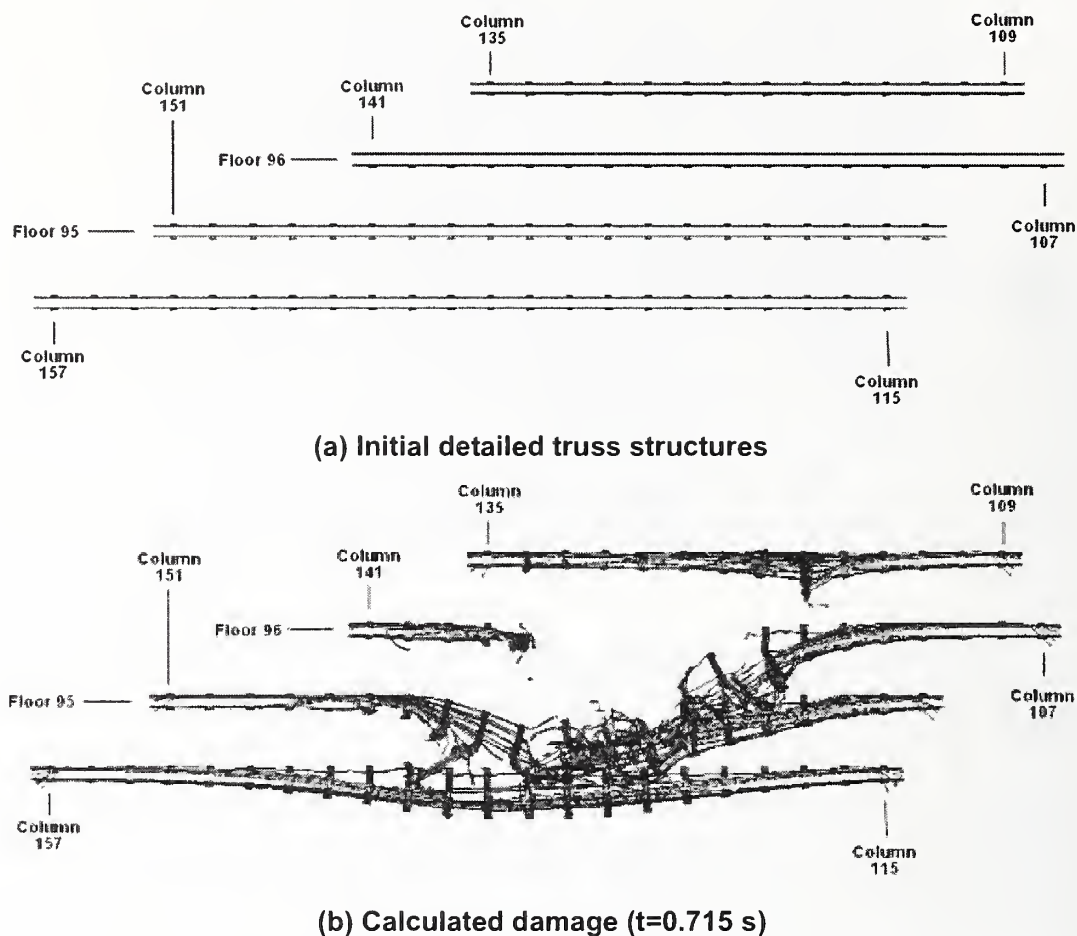
An overall view of the floor truss structure in the impact zone, along with the calculated impact damage to the floor trusses, is shown in Figure E-32. The figure shows that the trusses experienced significant damage in the impact zone. The calculated impact response produced severe damage to the truss structures in the primary impact path of the fuselage. The truss structures were severely damaged from the exterior wall to the core. The truss floor system on floors 94 through 96 were damaged and sagging downward as a result of the impact loading.

Figure E-32. Base case impact damage to the WTC 1 floor truss (front view).

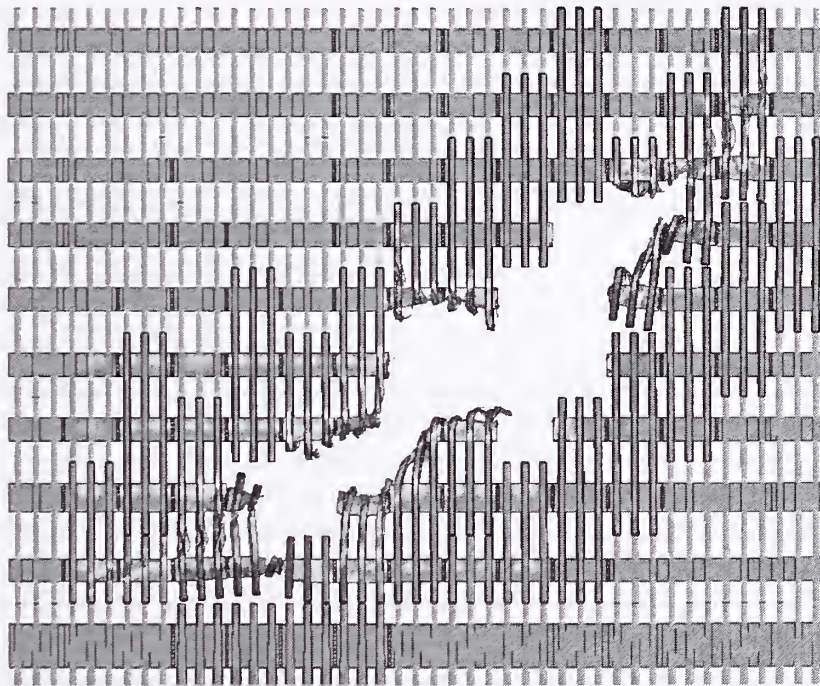
(a) Schematic of observed damage

(b) Calculated damage ($t=0.62$ s)

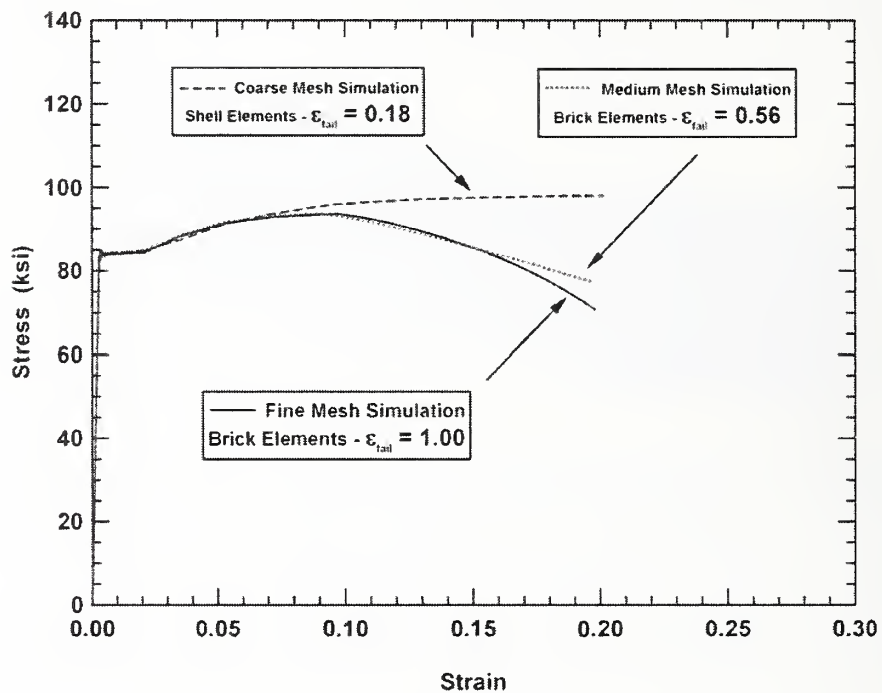
Figure 2–15. Mesh refinement effects in the calculated 75 ksi tensile test.

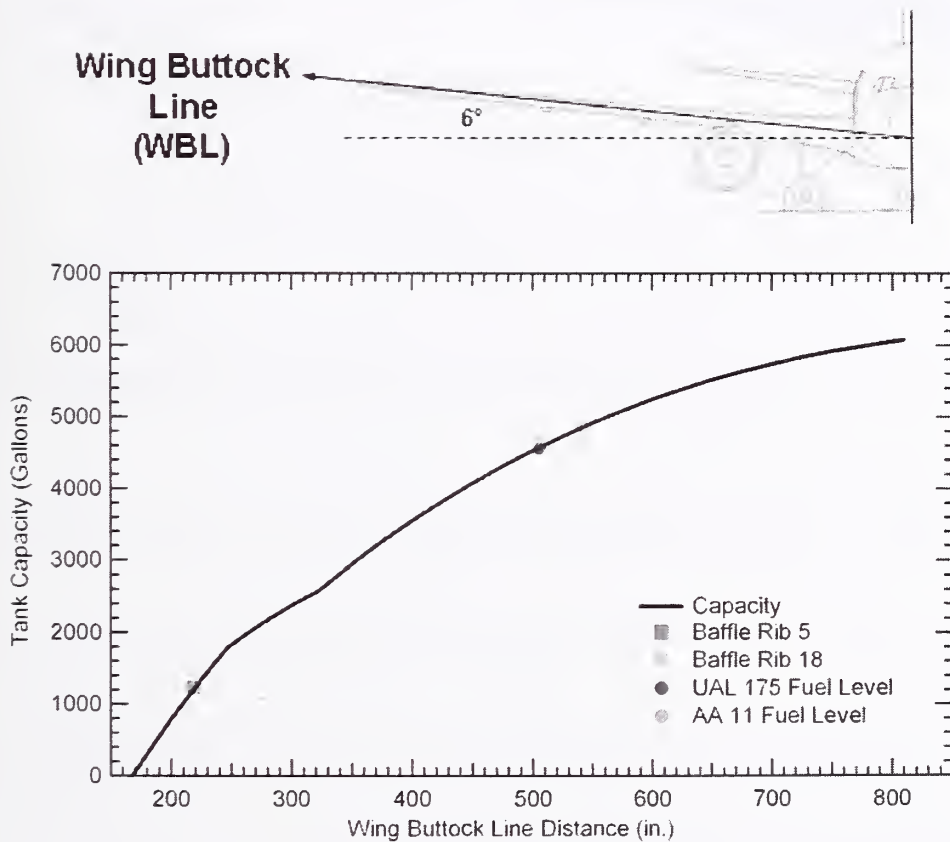
Figure 4-34. Fuel tank capacity.

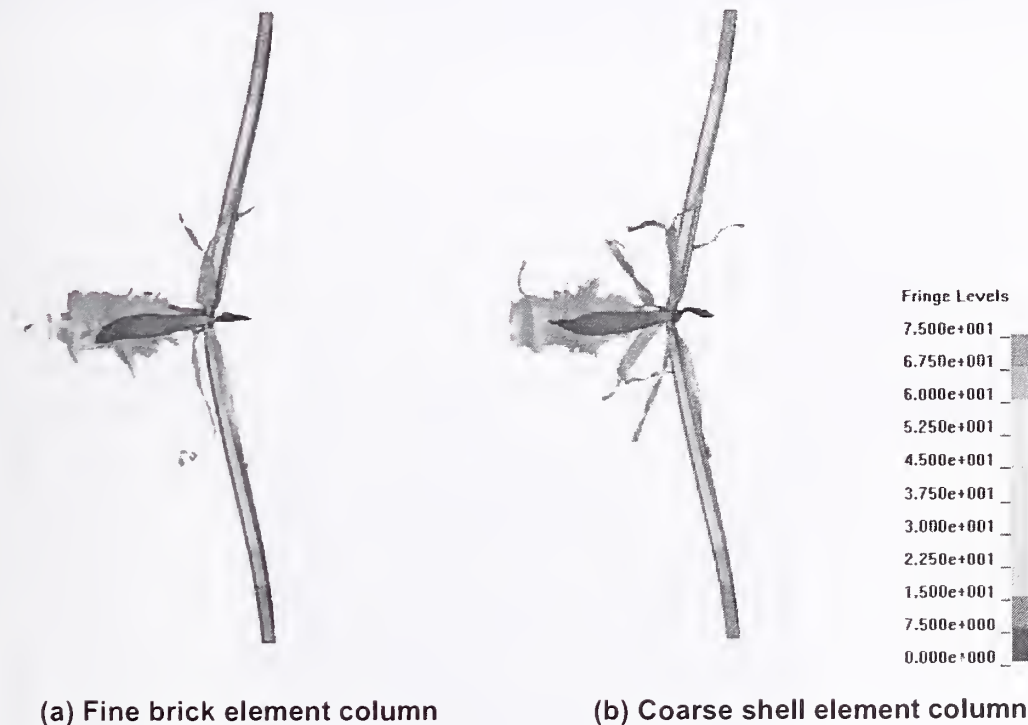
Figure 5–6. Wide flange core column response comparison, showing contours of the displacement magnitude (inches).

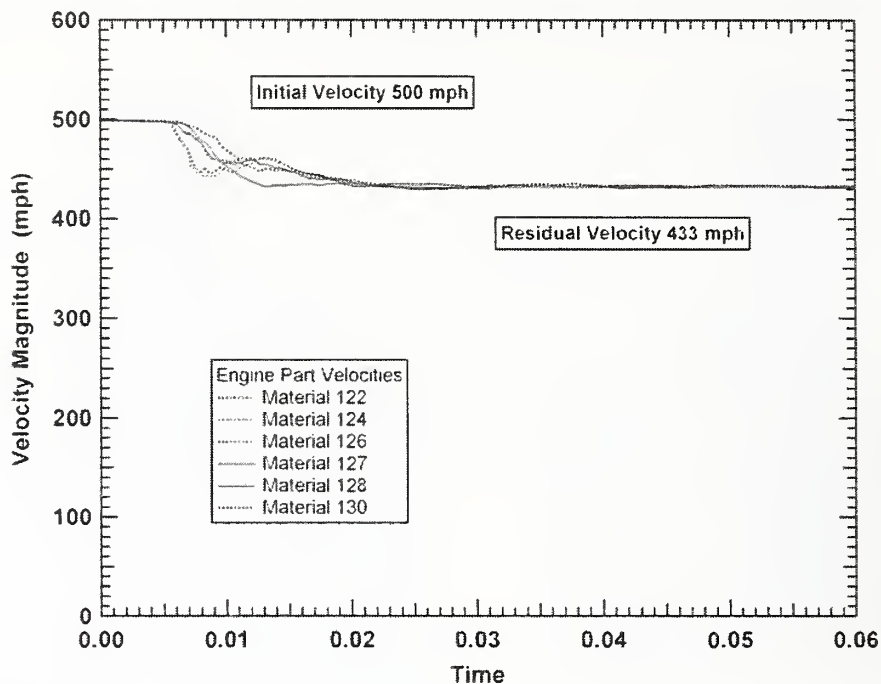
Figure 5–16. Engine velocity history for the exterior wall impact.

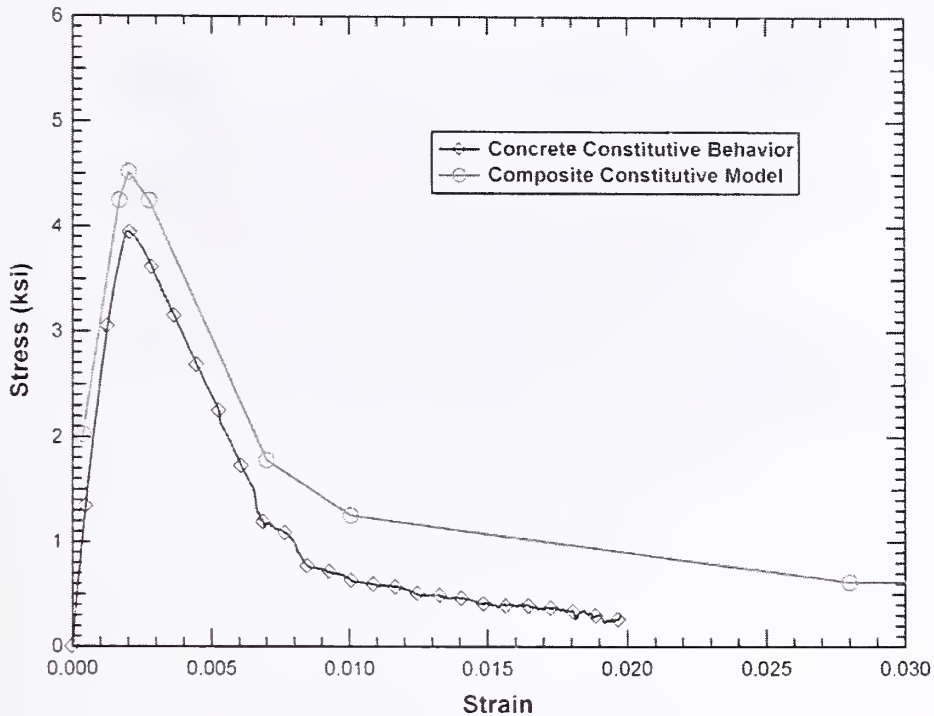
Figure 5-24. Constitutive behavior for the combined concrete and metal decking.

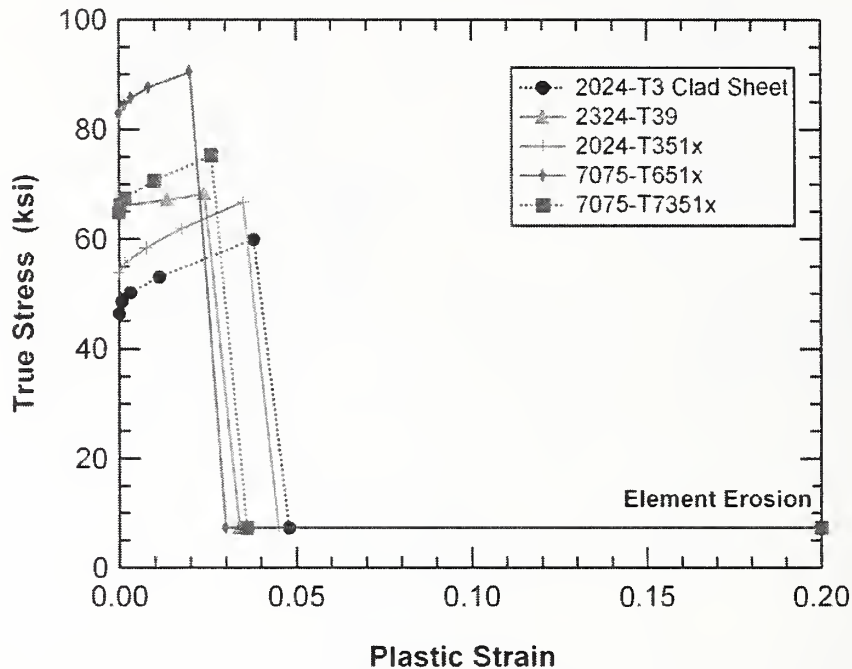
Figure 5–36. Aluminum model for coarse-mesh aircraft components.

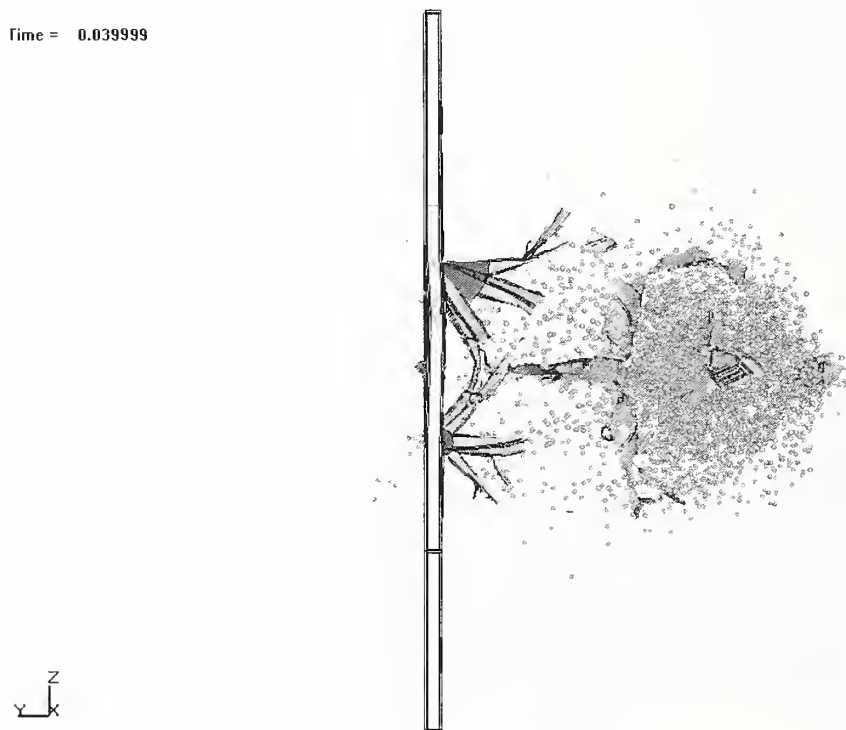
Figure 5-47. SPH analysis of structural damage and fuel dispersion (side view).

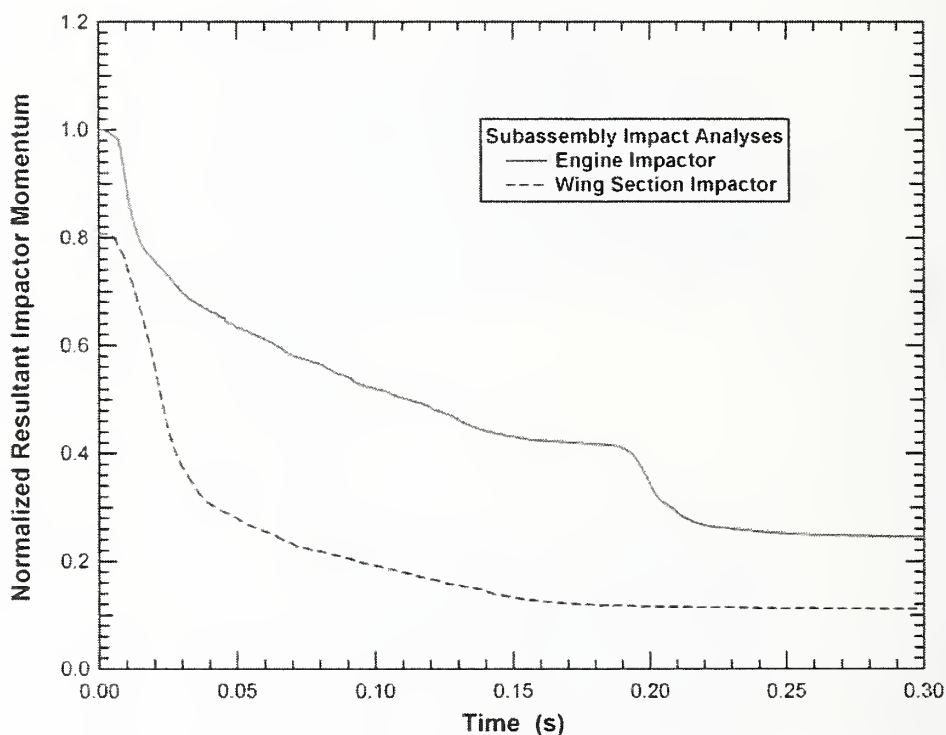
Figure 6–15. Impactor momentum histories for the engine and wing section analyses.
